## System Port Connectivity Issues with some Windows 10 (or later) Personal Computers

The AcraDyne® Generation IV ACE Platform Controllers utilize a commonly used device known as an RNDIS/Ethernet Gadget as a means to connect a PC to the controller. This device in essence allows a USB port to connect to a device in a similar manner as an Ethernet Port.

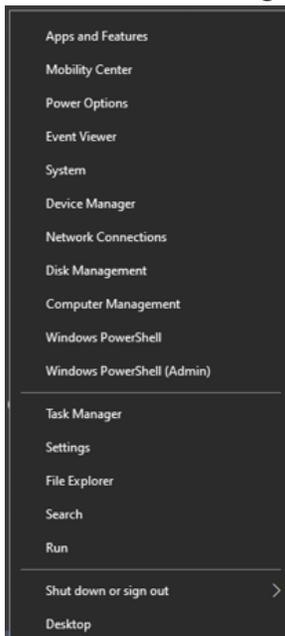
- Right click on **Windows icon**

(lower left corner on most desktops)
- Click on **Device Manager**

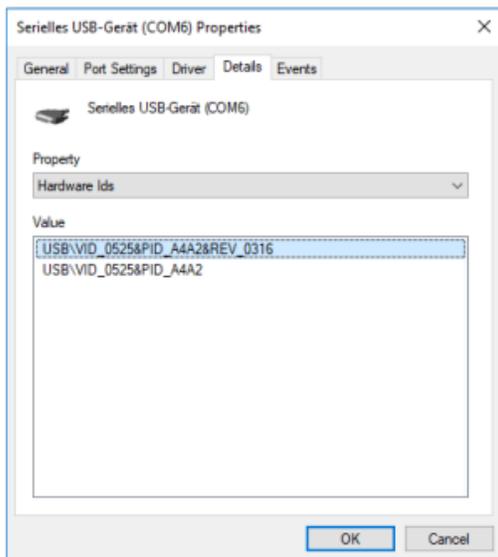
- **Confirm device** is the correct one by disconnecting the cable. The COM port identified device will disappear from the list when cable is removed. Upon re-installation of the cable, the COM port will reappear on the list. This confirms that it is the correct one to work with
- Right Click on the Device (identified as a COM port as above) and select **PROPERTIES**

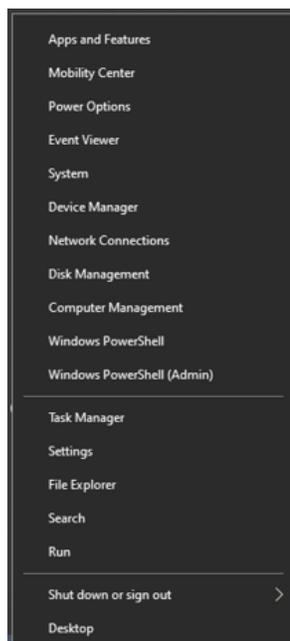
(lower left corner on most desktops)
    - Click on **Search**

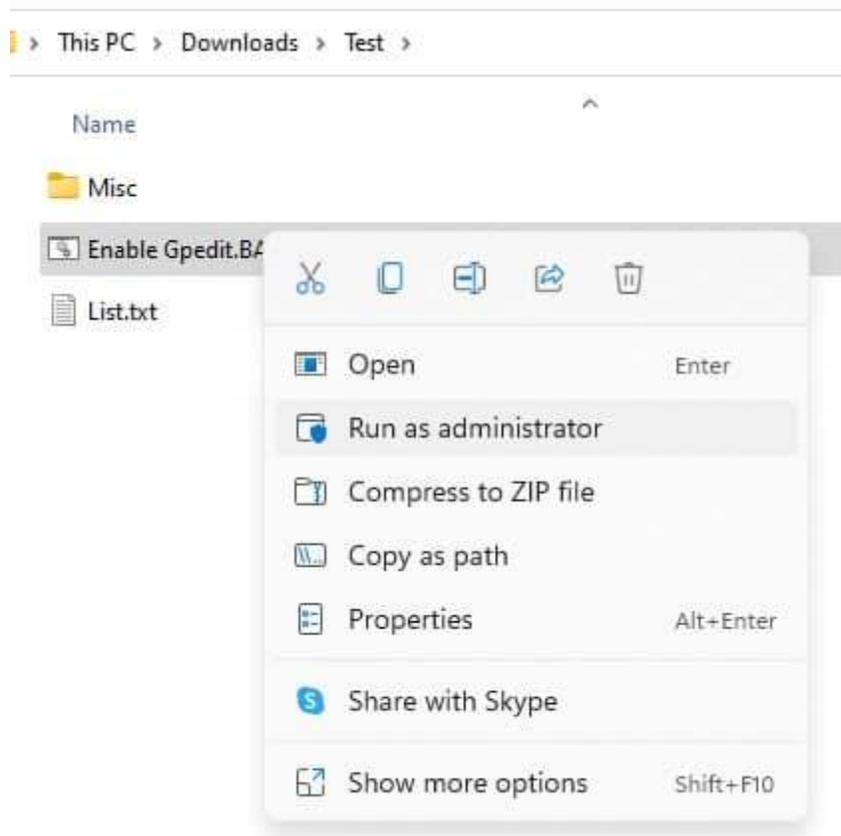
- Right-click on the BAT file that was saved and Run it as Administrator.

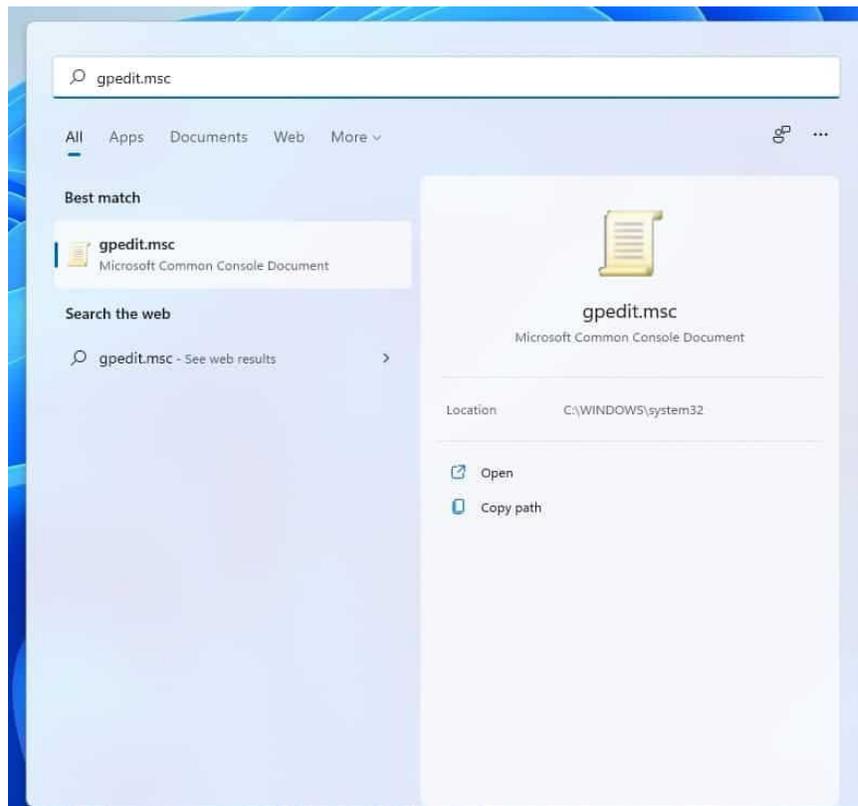
- Tap any key and the command window should close.
- Click the Start button and type Gpedit.msc, and you should see the tool appear in the result click on it (or use the Run command with Win + R, followed by Gpedit.msc), and you will be able to access the Group Policy Editor. (In some cases you need to restart your computer so you can find Gpedit.msc)

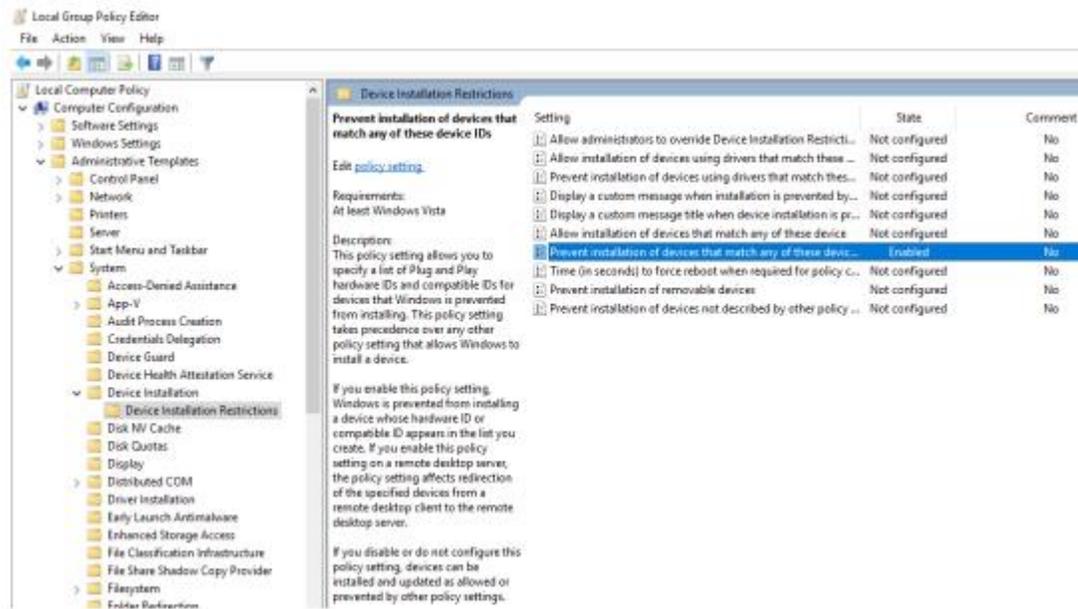
- With Gpedit.msc working in either Windows 10, Windows 11 or Windows 11 Home, you can move forward with these steps:

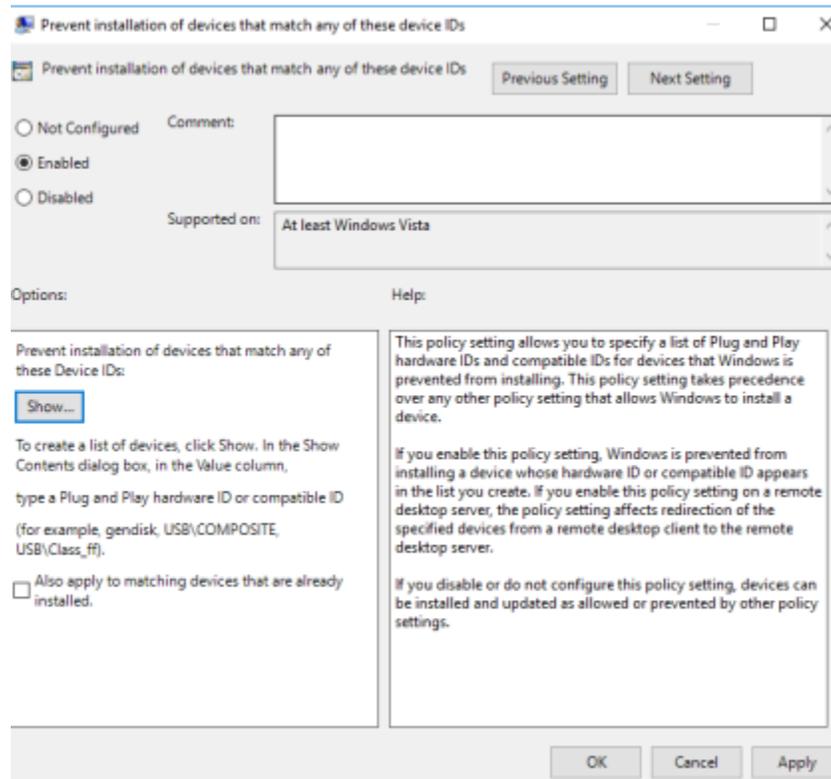
- **Navigate** through the menu tree
  - **Computer Configuration**
    - **Administrative Templates**
      - **System**
        - **Device Installation**
          - **Device Installation Restrictions**
- Double click on **Prevent installation of devices that match any of these device IDs**
- On left side of the screen, click on **Enabled**
- Lower down the screen on left side, click on **Show**

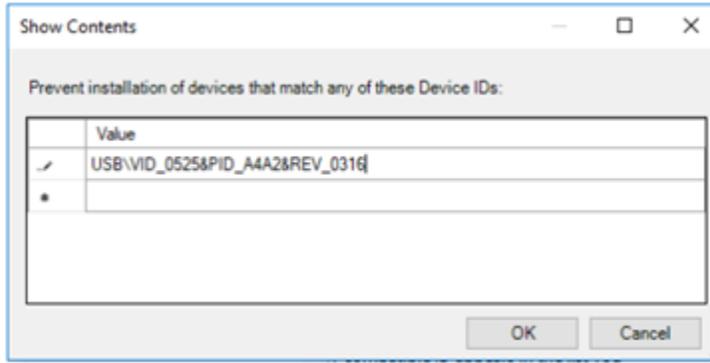
- In **Show Contents** box that appears, click on a blank like and **right click, paste** to place previously copied device ID to this window. This is what tells the PC that when it sees this device do NOT assign as a COM port

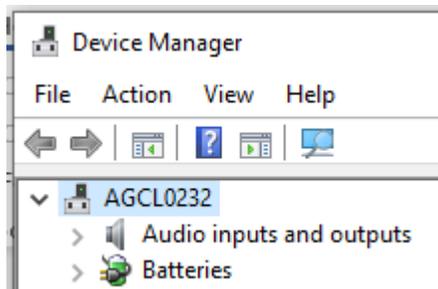
- Download driver for RNDIS Ethernet Gadget. Navigate to <https://www.aimco-global.com/software> and click on **GEN IV System Port Connectivity – Windows 10 RNDIS Driver**
- The driver will automatically download a Zip file to your PC's Download folder. Copy and name the folder **RNDIS Driver** and place into Documents. Unzip folder to Documents so it has a home on the PC that can be found easily
- Return to **Device Manager** (still open from Step 1). **Right Click** on the device the PC assigned as a **COM port** in the beginning.
- Select **Uninstall Device** and the **COM port** assigned device will be removed
- At the top of the Device Manager screen, click on the **Monitor Icon** which will scan for Hardware Changes
